CASE REPORT:

This case highlights the use of Friction Management Techniques using ShearBan® Friction Relief Patches.

Patient Demographics:

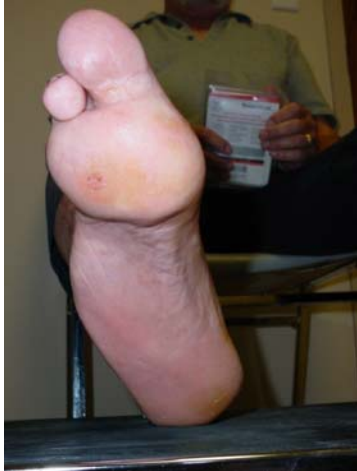
Right foot at 1st consultation

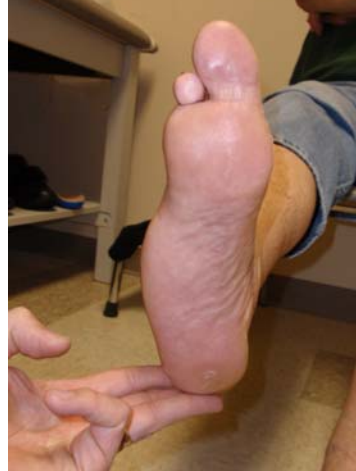
Mr. X was seen for follow-up of orthotic management every two weeks after the initial visit, and remained compliant wearing his shoes and inserts full time. Over the course of 11 weeks of treatment (6 office visits) the ulcer healed completely, and as of this writing, he remains ulcer-free for an additional 20 weeks.

After 11 weeks of treatment

*Note: Area beneath the calcaneus appears to be callusing, but is actually dermatitis. This is not a pressure/shear situation.

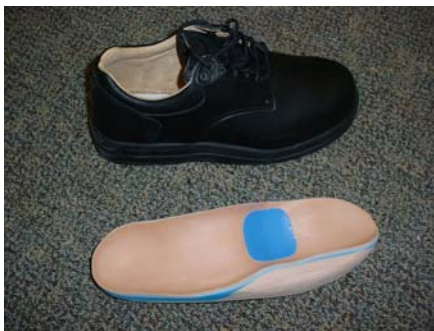
In addition to the usual pressure management techniques, shoe fit and modifications, ShearBan[®] was applied to the areas of plantar ulceration and high pressure on the accommodative inserts. The patch of ShearBan[®] material was heat/vacuum inlayed into the insert.

Devices provided for right foot

For orthotic management of Mr. X, I recommended depth inlay shoes (with extended steel shanks and forefoot/hindfoot rocker soles), custom multi-density accommodative inserts (1/2" blue puff, PPT, and pink plastizote using usual pressure management designs/techniques), and local friction management using ShearBan[®] applied to the areas of plantar ulceration and high pressure.

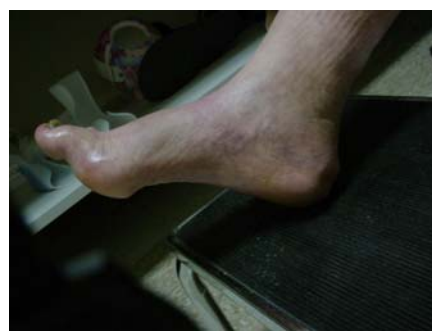
Sagittal view of right foot
(rigid deformity)

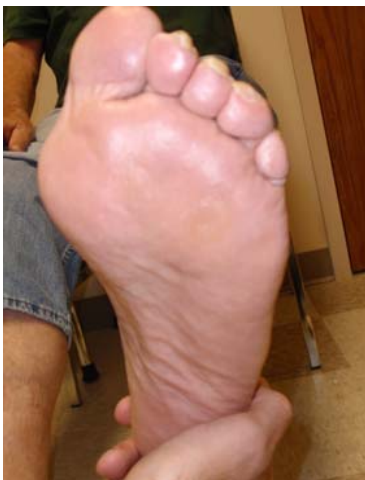
Left foot at treatment onset

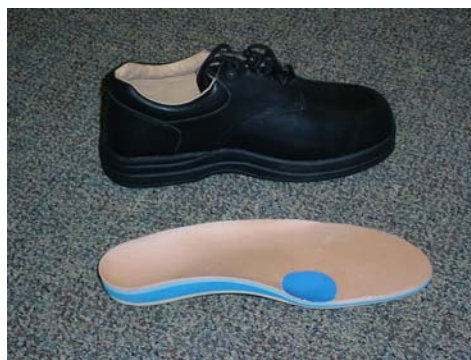
Devices provided for left foot
