Friction Management Techniques using ShearBan[®] Friction Relief Patches.

Charles Kuffel CPO, FAAOP, President/Clinical Director
Arise Orthotics and Prosthetics, Inc. Minneapolis, MN USA

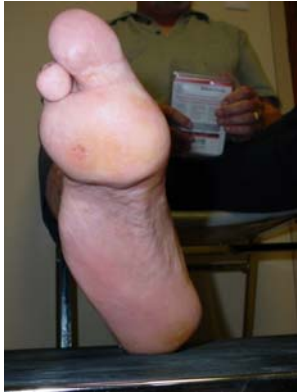
Right foot at 1st consultation

*Note: Area beneath the calcaneus appears to be callusing, but is actually dermatitis. This is not a pressure/shear situation.

Mr. X presented to me originally as a new patient with a history of re-occurring ulcerations on his right (neuropathic) foot. On this foot he has sustained multiple ray amputations due to these ulcers, and continues to be at great risk. He has been seeing a vascular surgeon for the past 5 years for these problems. At our original consultation he had plantar surface ulceration of the 2nd metatarsal head of his right foot and an ulcer on the dorsum of the second ray. Although his other foot (the left foot) appeared to be in good condition, he presented with considerable metatarsal prominence with neuropathic toe extension and clawing of the toes. At the time of consultation, Mr. X was wearing a commercially available forefoot offloading boot with a plantar foot bed which terminated proximal to the metatarsal heads (this is the location of the first MTH plantar ulcer). Although biomechanical principles seemed appropriate with this off-loading boot, the termination of the plantar footplate prevented the ulcer from healing.

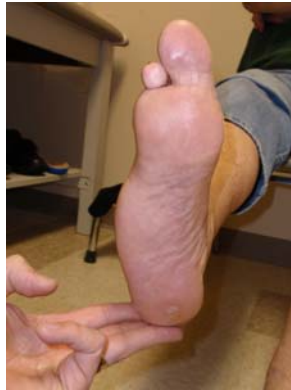
After 11 weeks of treatment

Mr. X was seen for follow-up of orthotic management every two weeks after the initial visit, and remained compliant wearing his shoes and inserts full time. Over the course of 11 weeks of treatment (6 office visits) the ulcer healed completely, and as of this writing, he remains ulcer-free for an additional 20 weeks.

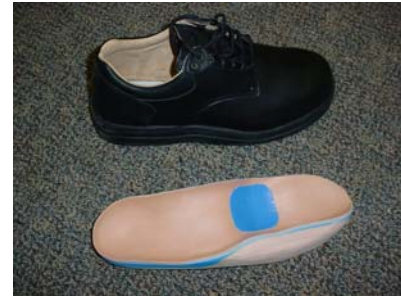
Devices provided for right foot

For orthotic management of Mr. X, I recommended depth inlay shoes (with extended steel shanks and forefoot/hindfoot rocker soles), custom multi-density accommodative inserts (1/2" blue puff, PPT, and pink plastizote using usual pressure management designs/techniques), and local friction management using ShearBan[®] applied to the areas of plantar ulceration and high pressure.

In addition to the usual pressure management techniques, shoe fit and modifications, ShearBan® was applied to the areas of plantar ulceration and high pressure on the accommodative inserts. The patch of ShearBan® material was heat/vacuum inlayed into the insert.

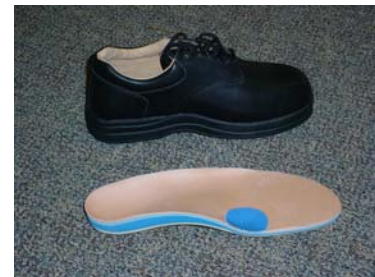
Devices provided for left foot
